**Response to NRC Review Comments
Transmitted by Letter Dated June 22, 2001,
to the Nuclear Energy Institute Relating to**

***PWR Materials Reliability Program
Interim Alloy 600 Safety Assessment for US PWR Plants (MRP-44)
Part 2: Reactor Vessel Top Head Penetrations
EPRI TP-1001491, Part 2, May 2001***

MRP 2001-050NP

**Prepared by:
PWR Materials Reliability Program Alloy 600 Issues Task Group**

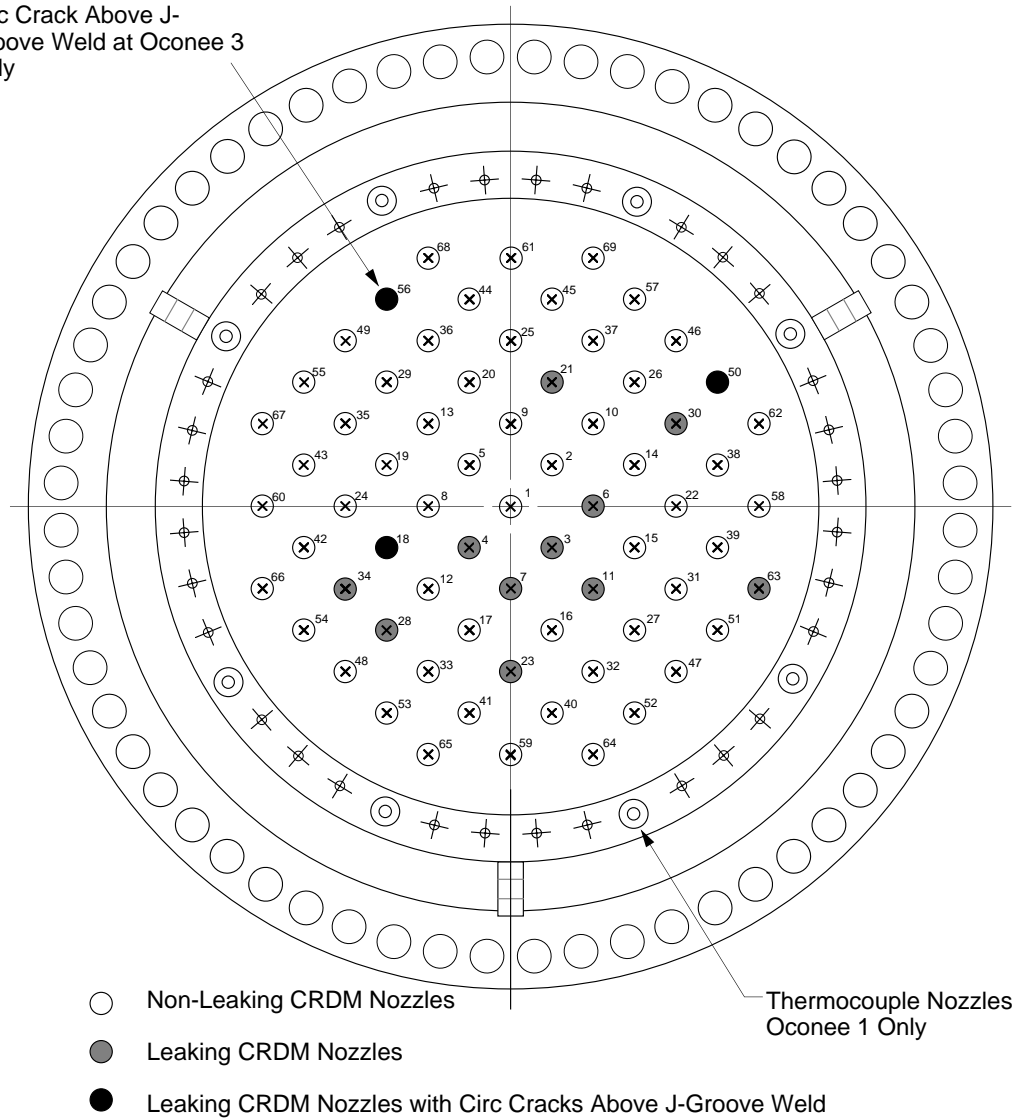
Figure 1
Locations of Leaking CRDM Nozzles at Ocone and ANO-1

- As shown in Figure 1, Oconee and ANO-1 experience demonstrates that leakage can be detected from nozzles adjacent to the central nozzle and in peripheral locations. This provides confidence that leakage can be detected regardless of location on the head.

Nozzle 56 Leaked at
ANO-1 and Ocone 3
Circ Crack Above J-
Groove Weld at Ocone 3
Only

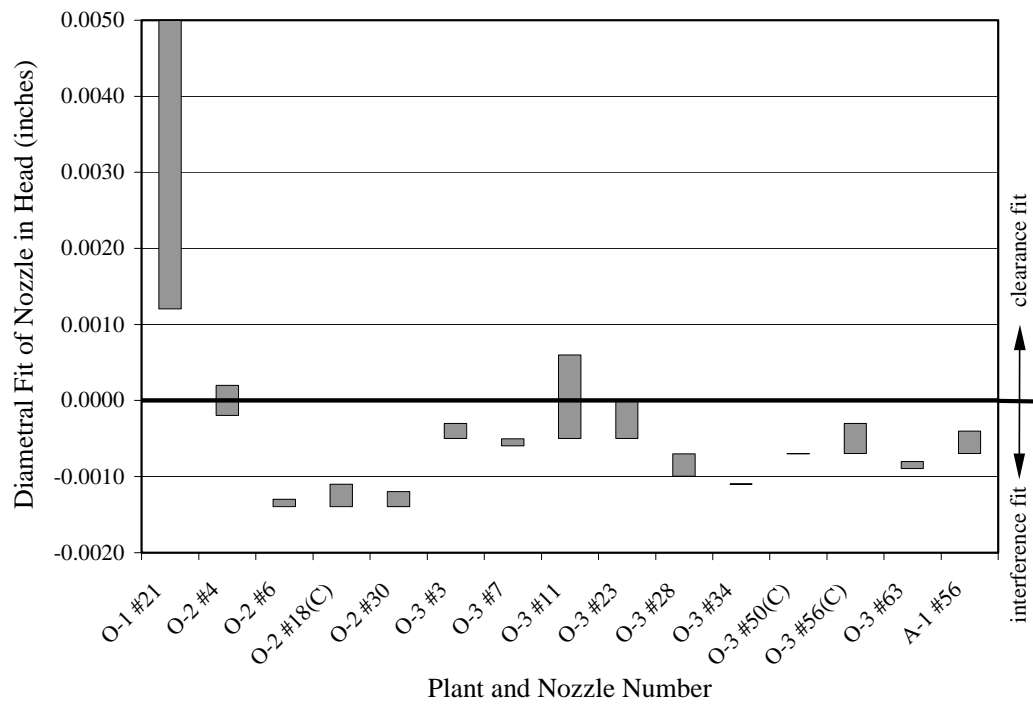
Figure 3
Actual Interference Fits of Leaking CRDM Nozzles at Ocone 1, 2 and 3 and ANO-1

Figure 3 shows the range of fits for the leaking CRDM nozzles at Oconee and ANO-1. The information provided during the June 7 meeting for Oconee 1, Oconee 3 and ANO-1 has been supplemented with data for the four leaking nozzles at Oconee 2. The three nozzles found to have circumferential cracks above the J-groove weld are appended with "(C)" in the figure.

The data in Figure 3 show that one nozzle had a clearance fit rather than the specified small interference fit. The remaining nozzles had at least one end of the interference fit region within the specified tolerance. It should be noted that three of the four leaking nozzles at Oconee 2 had interference fits of 0.0014 inches at one end and at least 0.0011 inches at the other end. In summary, leaks have been confirmed from fourteen nozzles with confirmed initial interference fits, including three nozzles with at least 0.0014 inches of assembly interference.

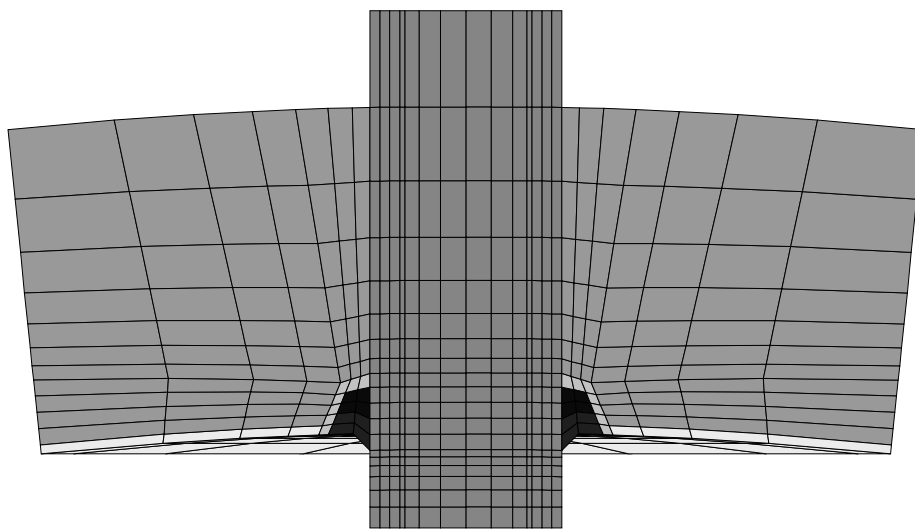
Figure 4
Typical FEA Model of Central CRDM Nozzle

Second order effects such as deflection and ovalization of oblique nozzles under pressure loading are assessed by finite element modeling of the nozzle and vessel head. Each of the NSSS vendors and EPRI has models of reactor vessel top head nozzles. Figures 4 and 5 show typical models of central and peripheral row CRDM nozzles and the associated J-groove welds. The models shown include the nozzle, a sector of the vessel shell, J-groove weld, J-groove weld buttering, and vessel cladding. Boundary conditions are imposed on the sector of the vessel shell to simulate the nozzle being installed in a complete spherical shell, and to model the initial

The model shown in Figures 4, 5 and 15 was not used to calculate crack tip stress intensity factors directly. Stress intensity factor calculations are currently being sponsored by the MRP using the finite element analysis results as inputs. Until such time as the finite element based stress intensity calculations are completed, calculations of crack growth have been performed using more traditional models such as described under Section 5.0 Comment 1.

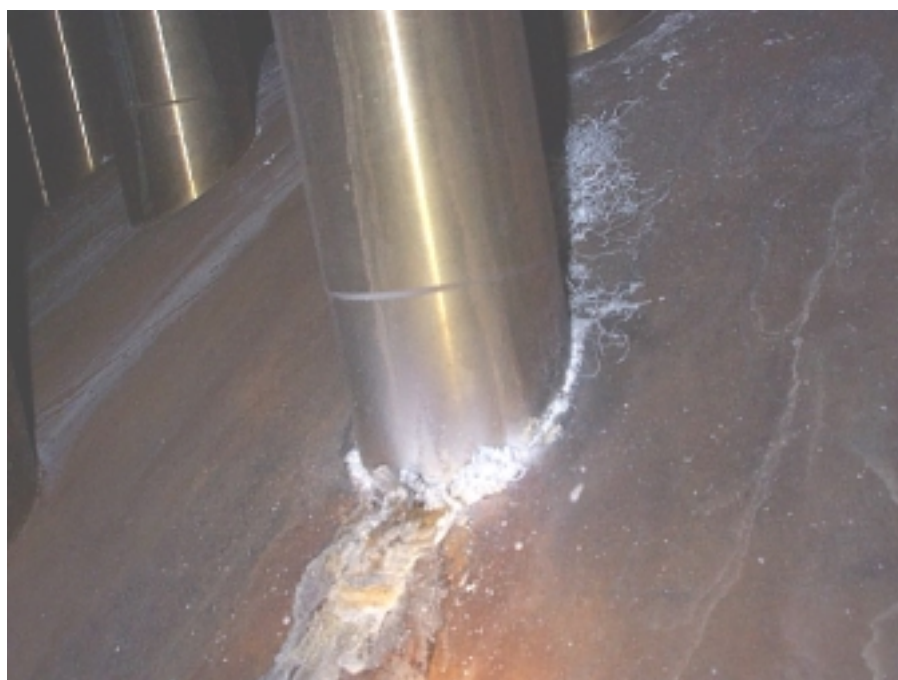
Figure 7
Visual Inspection of Oconee 3 Reactor Vessel Head (Leaking Nozzle 56)

- Figure 7 is Oconee 3, where visual inspection was performed through access ports that had previously been cut in the shroud. Leakage is clearly visible in the photograph.

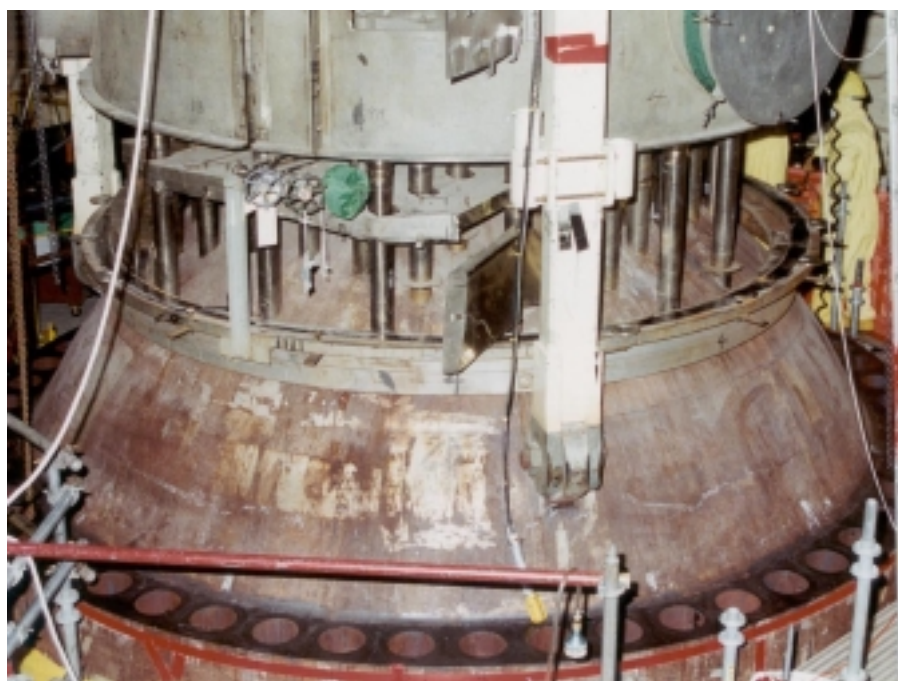
Figure 8
Visual Inspection of Salem 1 Reactor Vessel Head

- Figure 8 is Salem 1, where the shroud was raised several feet and the outer vertical panels of reflective insulation were removed. This provided excellent visual inspection conditions. No leakage was detected.

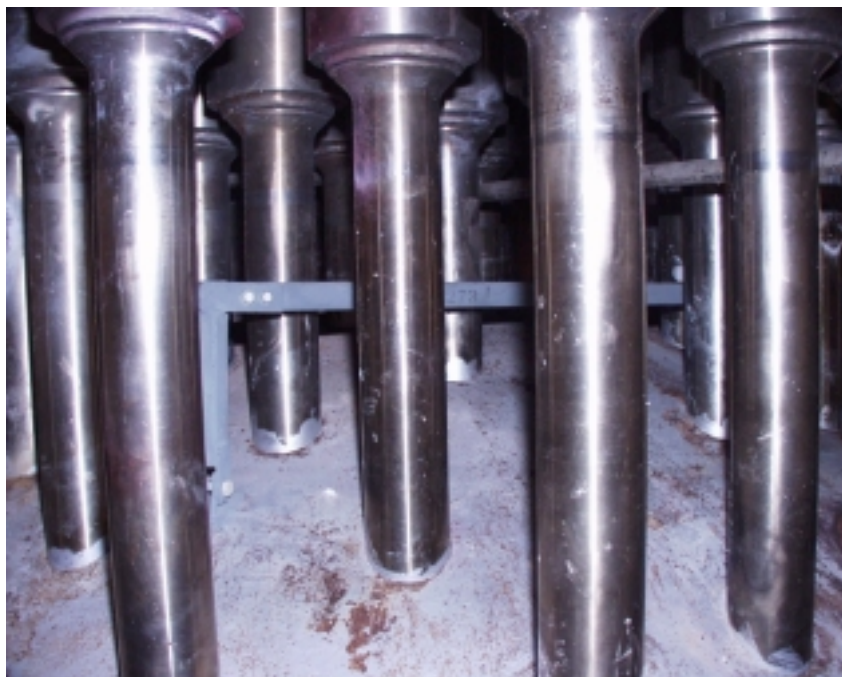
Figure 9
Visual Inspection of H. B. Robinson 2 Reactor Vessel Head

- Figure 9 is H. B. Robinson 2, where the original reflective type insulation was removed, and then replaced by blanket type insulation after the inspection was completed. No leakage was detected.

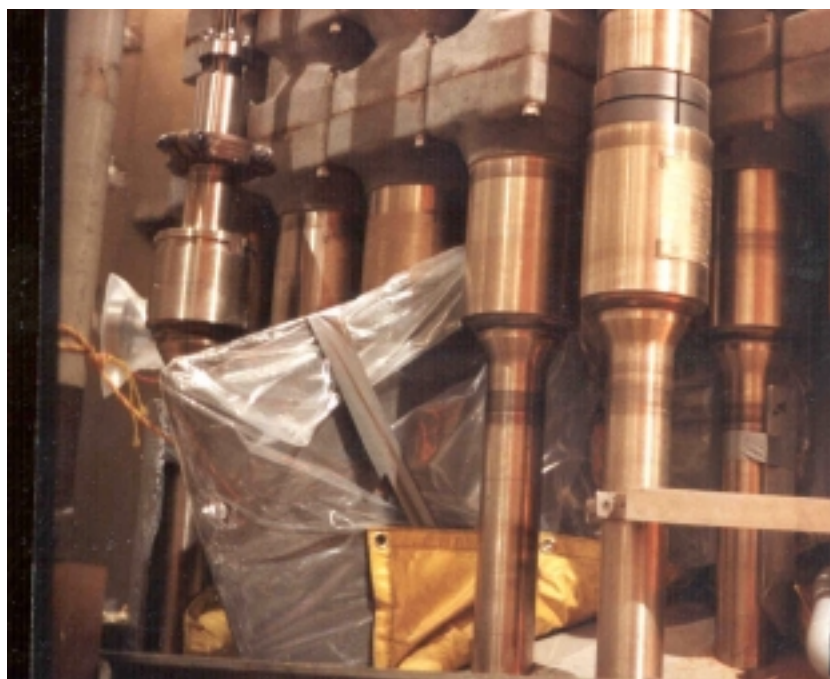
Figure 10
Visual Inspection of Prairie Island 1 Reactor Vessel Head

- Figure 10 is Prairie Island 1, where the head was modified to provide for visual inspection. No leakage was detected.
- Figure 11 is Farley 2, where the inspection was performed using a video probe inserted at joints in the metal reflective insulation. No leakage was detected.

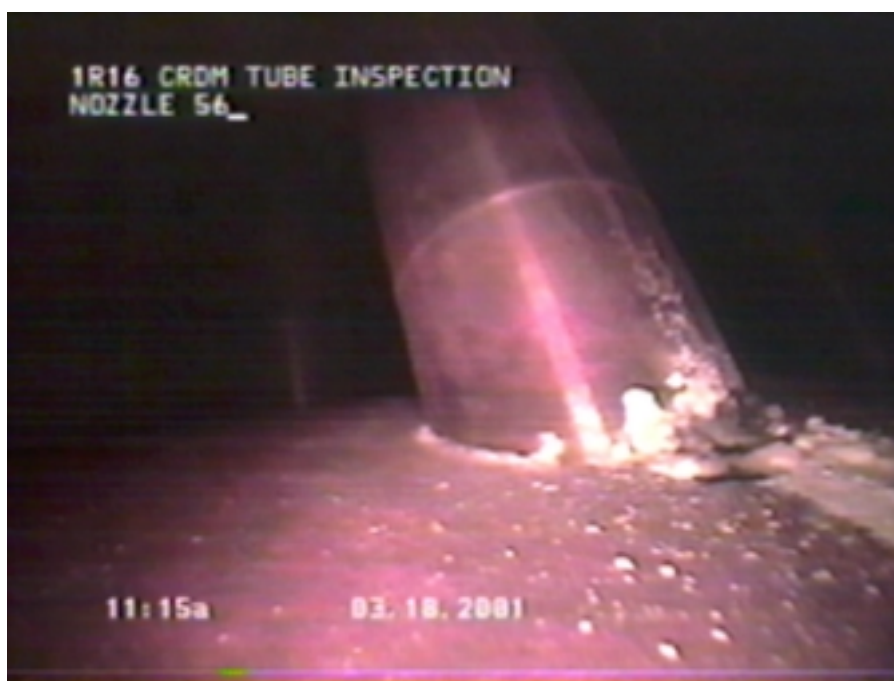
Figure 12
Visual (Video) Inspection of ANO-1 Reactor Vessel Head (Leaking Nozzle 56)

- Figure 12 is ANO-1, which performed inspections using a crawler inserted through a small hole in the shroud. Leakage is clearly visible in the photograph taken from the video camera record of the inspection.

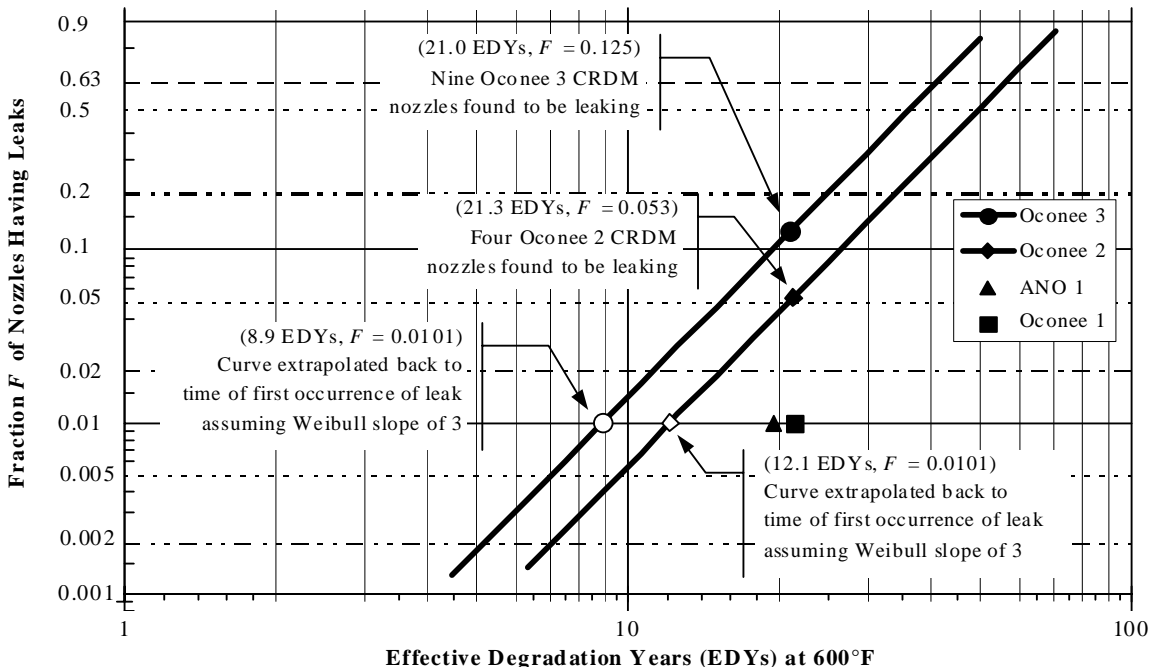
Figure 13
Weibull Plot of Fraction of Nozzles With Leaks vs. Effective Degradation Years

Figure 13 shows the fraction of leaking nozzles at Oconee 1, Oconee 2, Oconee 3 and ANO-1 plotted versus the effective degradation years (EDYs) adjusted to 600°F. The time to a first leak at Oconee 2 and 3 was estimated using a Weibull slope of 3 which is typical for PWSCC of Alloy 600 materials in the temperature range of interest. The data in this figure suggest that the initial leaks at Oconee 2 and 3 most likely occurred prior to initial detection in 2001.

The 10 year cutoff criterion was established by engineering judgment and by a Weibull analysis of the leakage experience at Oconee and ANO-1. A Weibull analysis was used since it provides a statistical model that shows the expected distribution of failures as a function of time. Industrial experience has shown that Weibull analyses provide good models for occurrence of PWSCC, both in nozzles and in steam generator tubes, as well as in laboratory SCC tests.

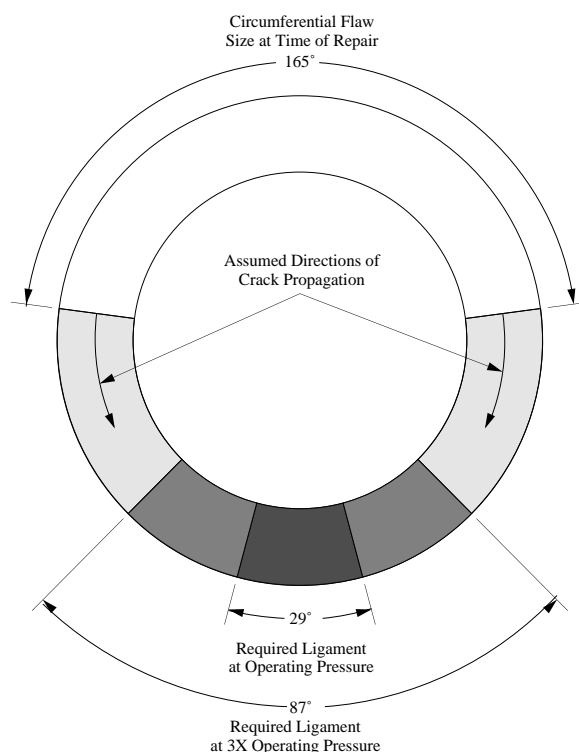
Figure 14
Direction of Crack Propagation

Both calculations were performed assuming that the cracks propagate in a circumferential direction around the nozzle from both crack fronts as shown in Figure 14. This is consistent with inspection results from Oconee 3 which showed that the cracks had essentially the same arc length on the inside and outside surfaces and is also consistent with the expected direction of primary crack growth for a through-wall crack in a cylindrical shell under internal pressure loading. Note that the finite element stress analysis results reported under Section 5.0 Comment 3, show that when the crack has reached 180° arc length, the welding residual stresses have been significantly reduced such that the primary direction of crack growth is expected to be around the nozzle as shown.

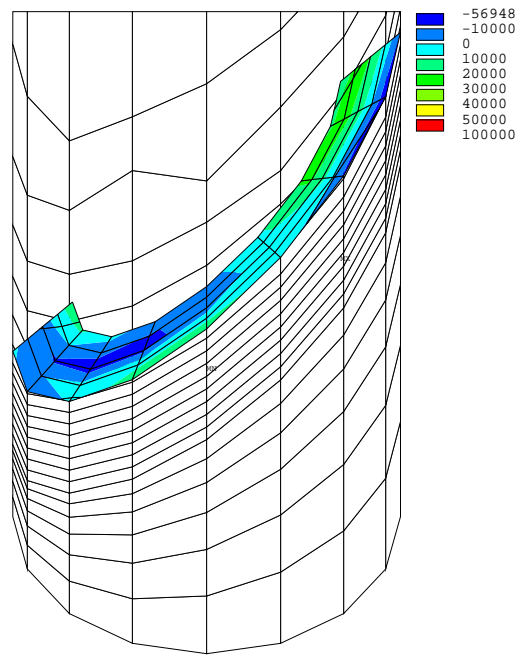
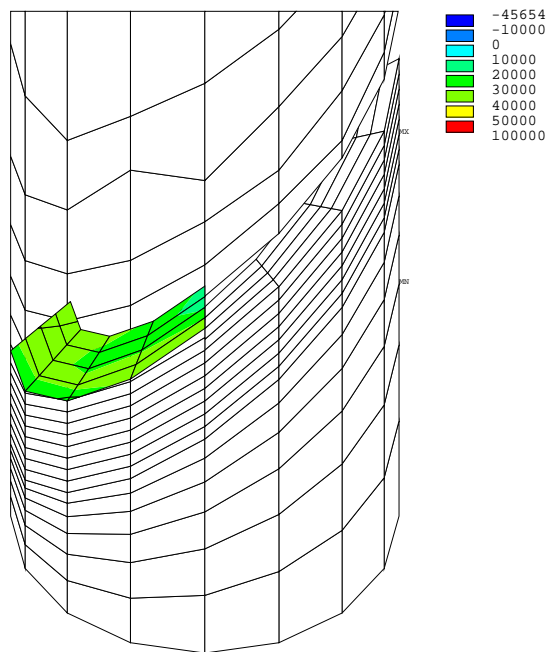
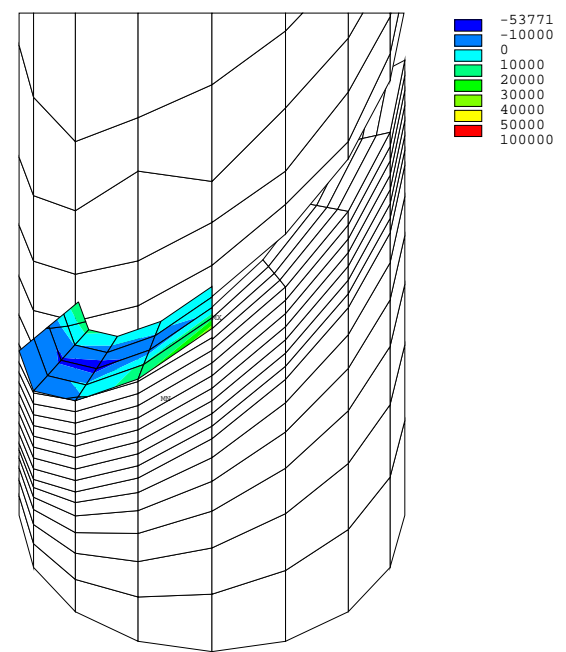
Figure 15
Stress Analyses of Peripheral CRDM nozzle in Intact (a) and Cracked (b) Configurations

Stresses Parallel to Weld (psi)

Stresses Perpendicular to Weld (psi)
